# FAILURES OF BRASS CONDENSER TUBES LOMOVI KONDENZATORSKIH CEVI OD MESINGA

Originalni naučni rad / Original scientific paper

Causes of failure of brass condenser tubes (CuZn28Sn1) in a thermal power plant in Serbia are analysed. Results of testing by Fourier transformed infrared spectroscopy (FTIR) have indicated the presence of ammonia and nitrogen compounds on fracture surfaces and on the inner surface of the tubes. These compounds are specific agents that cause stress corrosion cracking (SCC) in brass. Analysis of fracture surfaces using scanning electron microscopy (SEM) has shown the brittle transgranular fracture due to the occurrence of SCC. The resistance of brass condenser tubes to other types of corrosion, such as erosion, general and selective corrosion (dezincification) is also considered. Some procedures are proposed to reduce the risk of SCC in the brass condenser tubes.

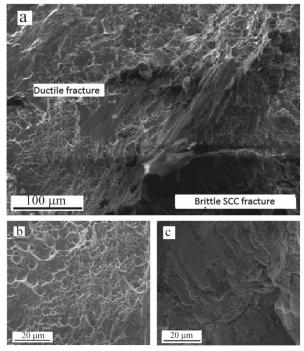
Figure 4. a) Fractured surface of brass condenser tube, b) ductile fracture is a result of mechanical action, c) brittle transgranular fracture is a result of SCC.

During the operating delay of the power plant, there are suitable conditions for SCC occurrence in the unclean brass condenser tubes, in the region of residual tensile stresses (the region of mechanical joining of condenser tubes to the backing plate). Initial cracks are formed in the inner wall of the tubes. The cracks started to grow at low rate through the tube wall, so that a relatively long time is needed for the cracks to reach critical size, when fast mechanical fracture has occurred. This phenomenon has been observed in a large number (several hundred) of brass condenser tubes. The fractured surface of the brass condenser tube is presented in Fig. 4. It can be seen that brittle transgranular fracture is a result of SCC. SCC fracture is always brittle (intergranular or transgranular) regardless of the level of alloy plasticity (brass), /3/. The final mechanical fracture is ductile type fracture in alloys with a higher degree of plasticity, such as brass.

Failure of brass condenser tubes occurred due to SCC, because the necessary conditions for the SCC occurrence were fulfilled. Fractographic (SEM) analysis shows that the fracture of brass condenser tubes is a brittle transgranular fracture caused by SCC, while the final mechanical fracture is ductile fracture. It is possible that SCC cracks exist in a certain number of brass condenser tubes, although the failure of these tubes has not occurred in the previous period. It can be expected that some of these condenser tubes will fracture during further operation of the thermal power plant.
