Scientific paper

Zastita Materijala 63 (4)

Choosing the procedure for repair of damaged arm at an unicate desk lamp

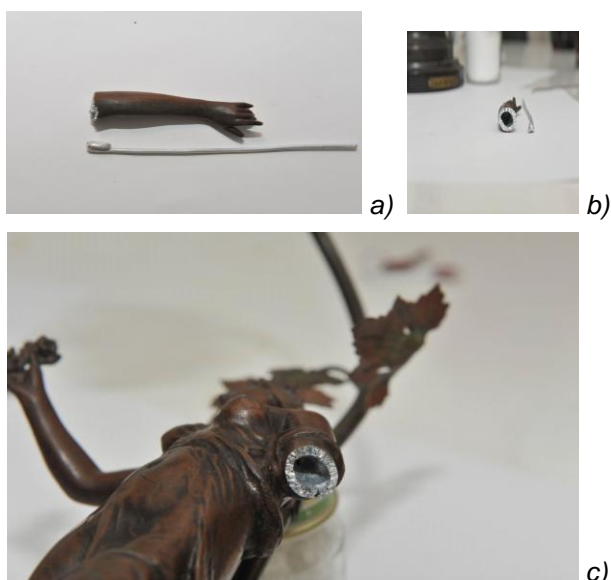
The lamp is damaged at the left side of statue, exactly on the arm near elbow but just over this place, see Fig. 2a). At this place the arm from the lamp was hollow, Fig. 2b).

Figure 2. Broken arm in two views a) and b); look at the lamp from downside c)

The inner diameter of hollow at broken arm was about 10mm, with wall thickness about 2mm. The depth of this hollow part was about 45mm. At the broken wall could be seen the great dendritic grains which is characteristic for as-cast structure of used alloy, see figs. 2b) and c). The hollow arm indicates that the lamp body is produced from various components which are first casted and then connected either by welding or brazing.

At damaged surfaces were not registered any defects originated from a casting period, as like shrinkage, slag or non-metallic inclusions, which generally may appear in as-cast structure, no matter what kind of alloy is used. Generally, as-cast structure is a brittle.

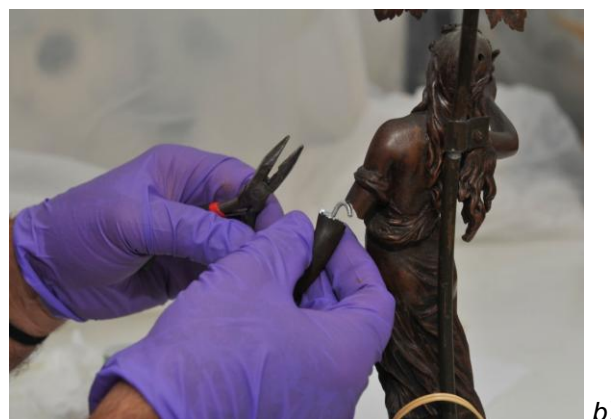
Figure 4. Preparing for reinforcing with aluminum wire

As the third possible way of repairing is considered on reinforcing of glue by inserting an aluminum wire, according to Fig. 4a). It is well known that the aluminum is an inert material in regard to parent material, it is an alloy made of zinc and aluminum, and from that point of view there is no dangerous for corrosion appearance between those materials. But, the limiting factor in this solution is the uncertaintyof such "construction", because it was impossible to fasten the aluminum wire to the lamp body, and then the

As the fourth way for repairing the damaged arm is accepted next solution: at the cavity of lamp body is remained one small pointlike pore, heavy visible. It is beleived that this pore was created during the casting process. But, the diameter of this pointlike pore, less that 0,5mm in diameter, is too small to sguetze through a wire with diameter 3mm, and made a strong connection. In situation like this, is concluced that will be enough first to fasten a screw. A chosen screw is about 20mm in length, \varnothing 3mm, and less than 0,5mm in diameter at the top. This steel screw was zinc plated (by using an ordinary galvanic process), what in this situation represents an advantage [12]. The remaining room will be fullfilled by the aluminum wire, Fig. 4b), together with a glue.
