INVESTIGATION OF THE ENERGY EFFICIENCY OF THE MILITARY MUSEUM BUILDING BY INFRARED THERMOGRAPHY

Slavica S. Ristić, GOŠA Institute, Belgrade,
Suzana R. Polić-Radovanović, CIK – Central Institute
for Conservation, Belgrade,
Bore V. Jegdić, GOŠA Institute, Belgrade

FIELD: Energy Efficiency
ARTICLE TYPE: Professional Paper

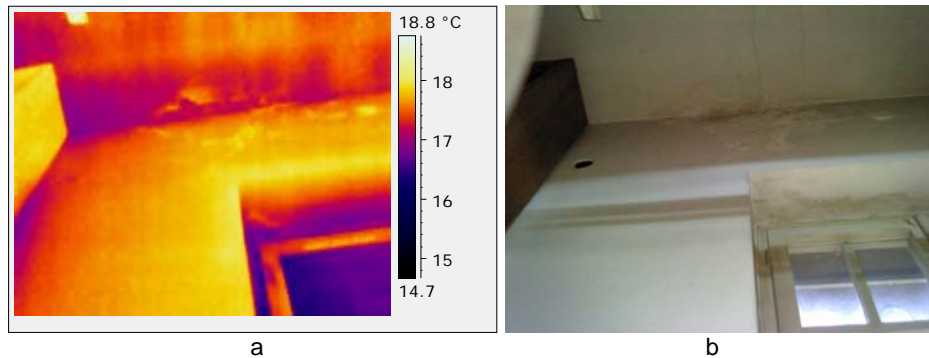
The moisture was not detected in the wall above the first (from left) window (Fig.2a). Poor sealing of the windows was recorded. Brighter parts of the thermogram represent the parts of the wall with a layer of plaster disbonded. The air under the plaster is a good insulator; therefore, these parts were warmer (brighter) than the rest of the wall.

Figure 2 – Part of the wall above the first left window
Slika 2 – Deo zida iznad prvog levog prozora

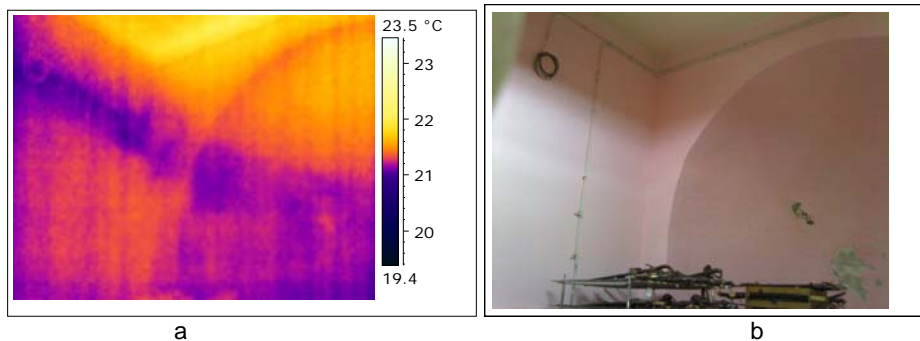
In the weapons depot, the temperature during the October test was $T_{in} = 21^{\circ}\text{C}$, humidity 60%. Under these conditions, the dew point would be when the temperature reaches 13°C . The concrete bridge (Fig.3a) is colder than the rest of the wall. It is a potential place for the condensation of moisture.

Figure 3 – Visible cold zones and the concrete beam in the weapons depot
 Slika 3 – Vidljive hladne zone i betonska greda u depo naoružanja

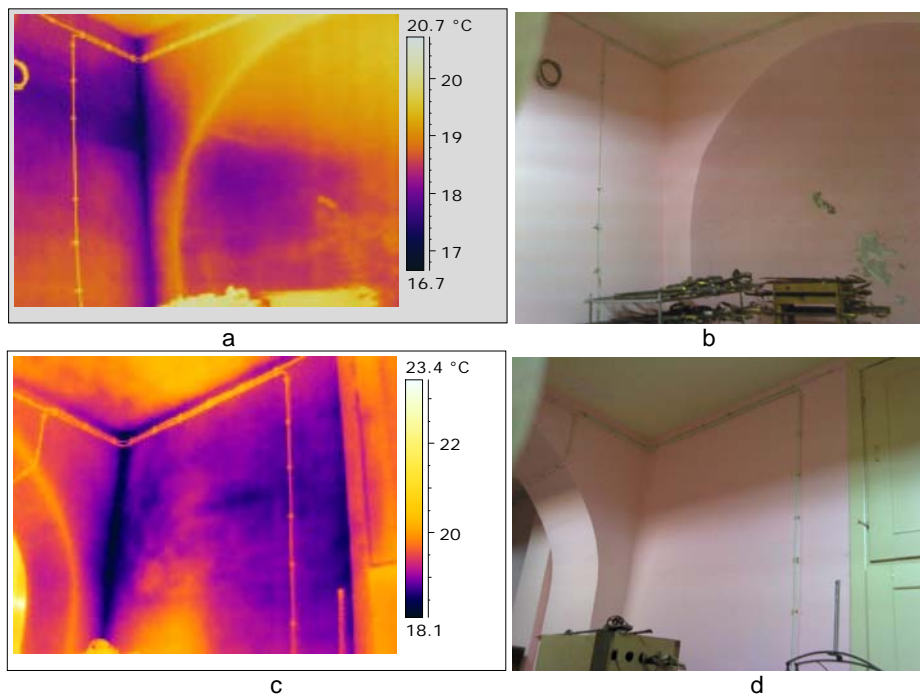
The second set of thermographic tests, performed two days after a heavy rain, ($T_{ou}= 5^{\circ}\text{C}$, $T_{in}= 20^{\circ}\text{C}$), displays the extent of the moisture intrusion in the weapons depot (Fig. 4). In the upper left corner (Fig. 4a), beside the cold concrete bridge, there was damp penetration since the depot is in the basement, below the ground level. A similar case is in the right corner, too. The electrical installations are visible as bright lines on both thermograms.

Figure 4 – Thermograms and the photos of the weapons depot with visible moisture
 Slika 4 – Termogrami i fotografije depoa naoružanja sa vidljivom vlagom

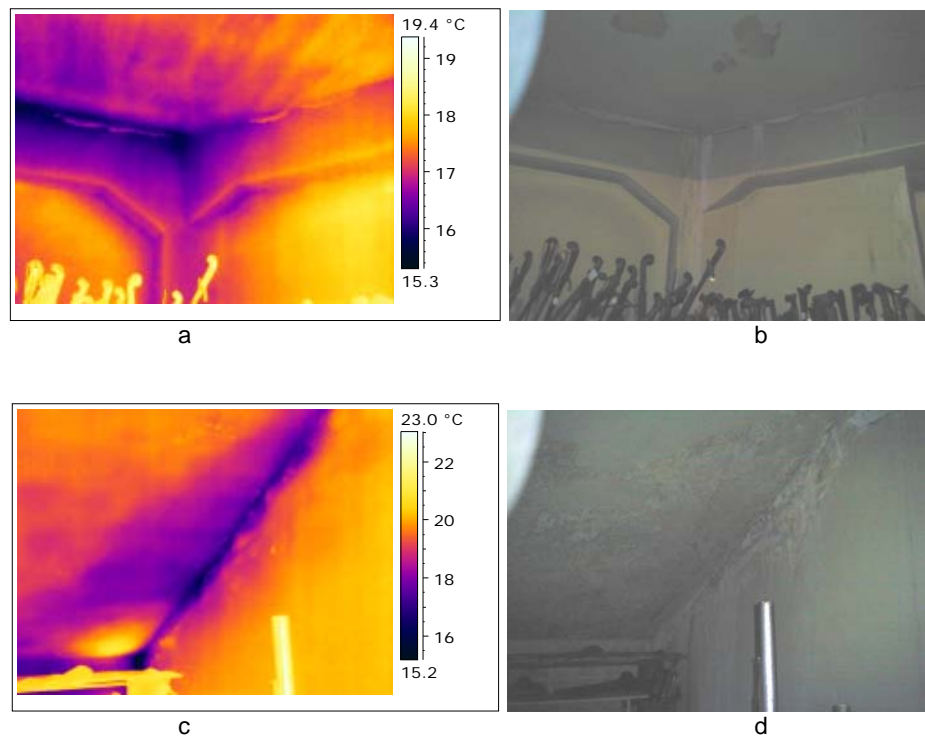
The presence of moisture in the depot where old metal artifacts are kept, contributes to the acceleration of corrosion and deterioration of exhibits. The thermographic inspection shows that moisture is penetrating from the roof and from the poor leakage location (Fig. 5).

Figure 5 – Some details of the old metal artifacts depot
Slika 5 – Nekoliko detalja depoa sa zbirkom starih metalnih eksponata

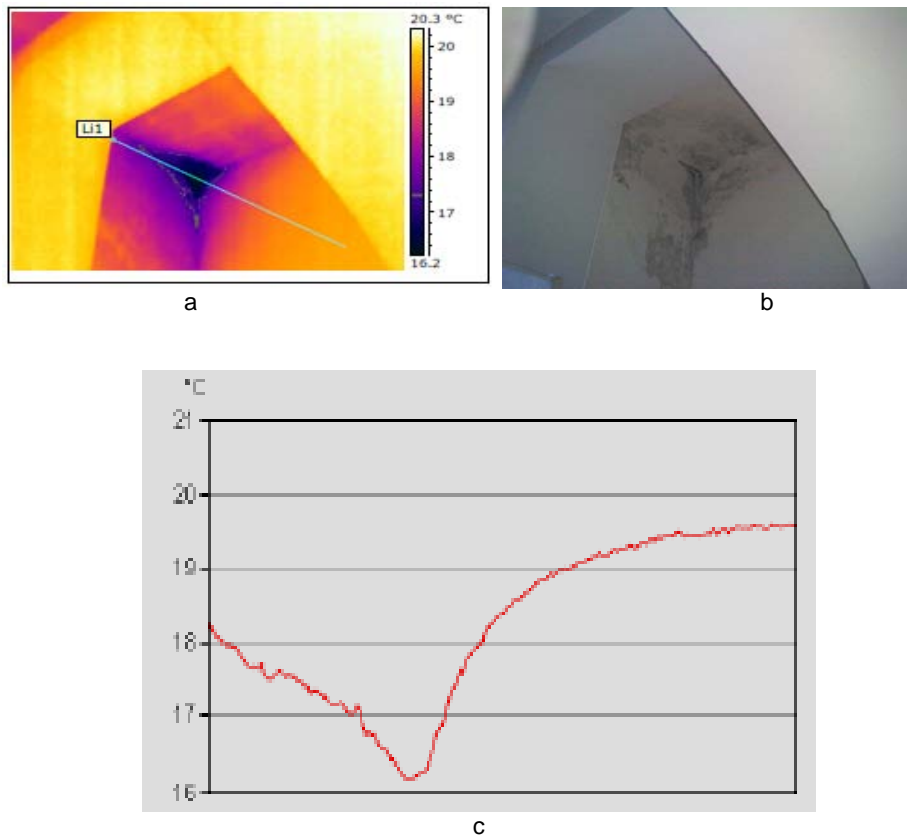
Moisture intrusion was detected in most of the inspected museum depots and other rooms,. The active moisture was detected in the depot of gifts, too. During the thermogram recording, the measured temperature was $T_{in}=20.8^{\circ}\text{C}$ and moisture was 53.7%. If the measured moisture retains, and the temperature lowers to $T_{in}= 10.8^{\circ}\text{C}$, then the condensation of moisture from the air appears on the walls. Figs. 6 show a part of the ceiling in the right upper corner with a-thermogram, b-digital photo and c-diagram of the temperature changes along the line tool.

Figure 6 – Part of the gifts depot
Slika 6 – Deo depoa sa zbirkom darova

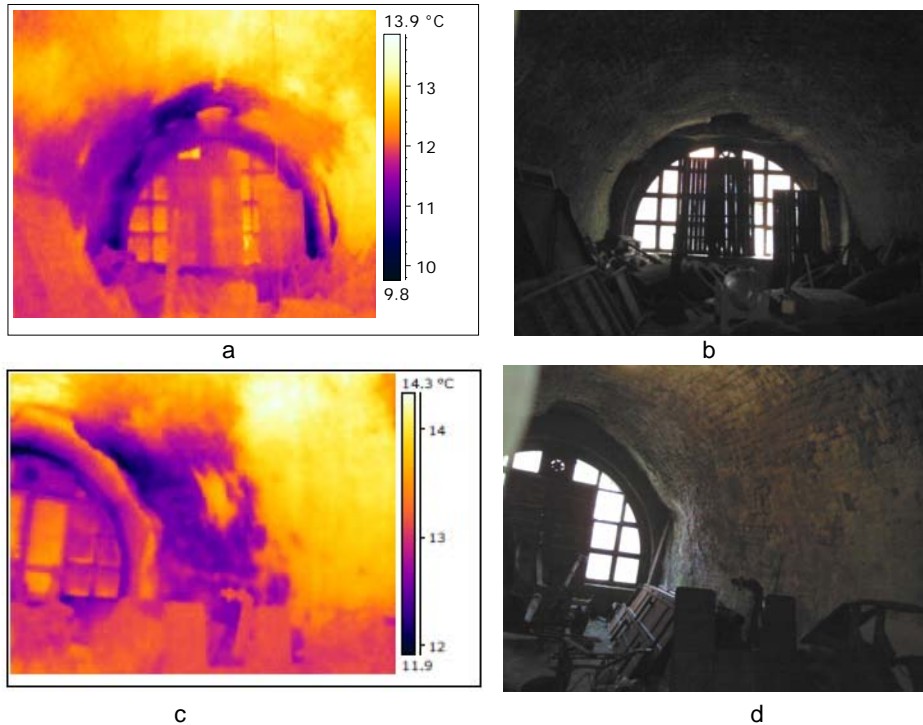
Fig. 7 shows the presence of moisture in the museum Casemates. The inspection was performed under these meteorological conditions: $T_{ou}=19^{\circ}\text{C}$, $T_{in} = 15.4^{\circ}\text{C}$, humidity of 67%, dew point temperature 9.3°C . Metal objects have been kept in the dungeons of the Military Museum at Kalemegdan, and the present moisture has a beneficial effect on the development of corrosion (Polić-Radovanović, Ristić, Jegdić, Nikolić, 2010), (Polić-Radovanović, 2010, p.161), (Jegdić, et al, 2011, pp.50-56), (Jegdić, et al, 2012, pp.169-182).

Figure 7 – Moisture in the museum Casemates, a,b – the first casemate
 c,d – moisture in the second one
 Slika 7 – Vлага u muzejskim kazamatima, a, b – prvi kazamat,
 c,d – vлага u drugom kazamatu

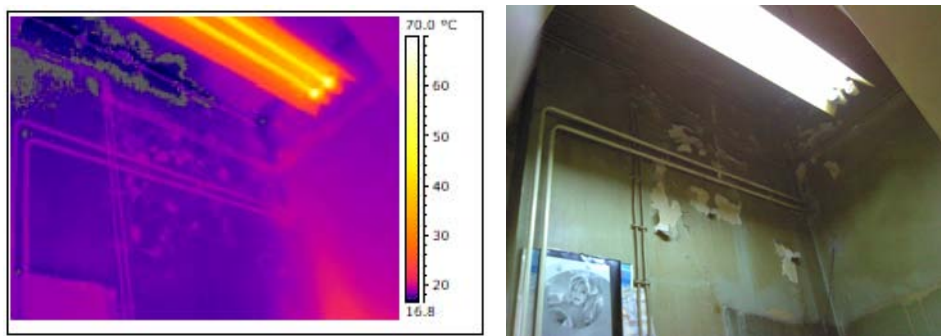
The workshop for metal conservation was investigated by thermography. The cold and damp workshop walls are presented in Fig. 8, (a thermogram-, b-digital photo, c-isotherm indicating that moisture covered the area).

Figure 8 – Appearance of the cold wall in the workshop for metal conservation
Slika 8 – Izgled hladnog zida u radionici za konzervaciju metalnih eksponata

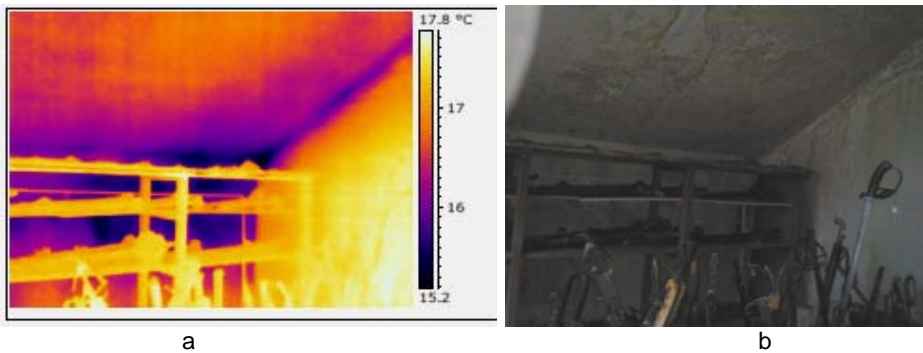
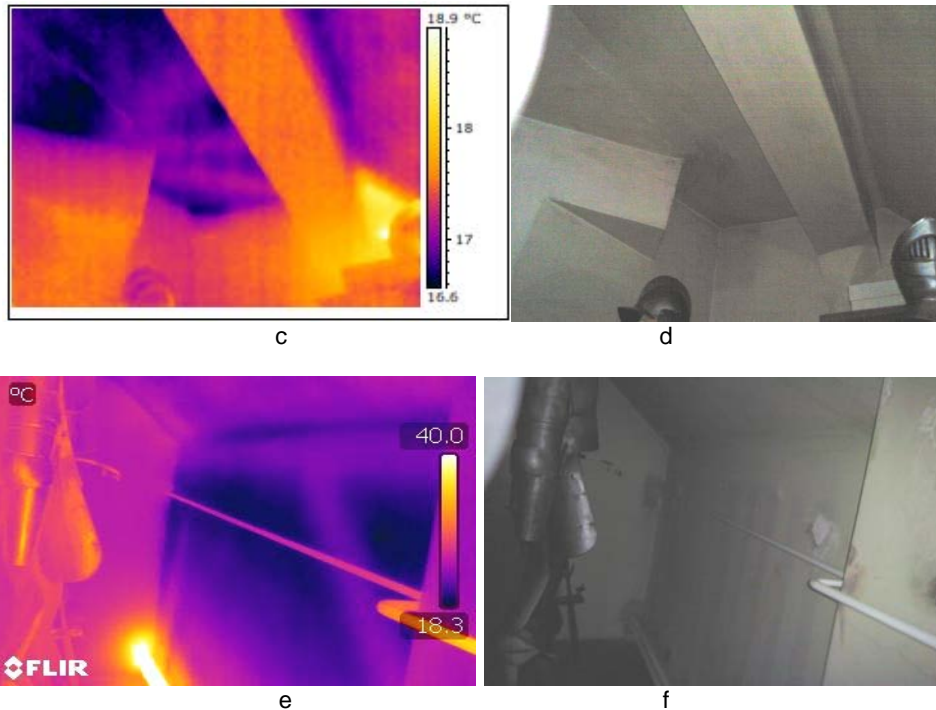
The collection of old metal artifacts is stored in the depot where the wall and the roof have poor thermal insulation. Figs. 9a to 9c show the

right corner of the depot. There are stains, but currently there is no moisture in the walls. The wall behind the shelves which restrict the access for thermographic inspection is colder than the other walls because of poor thermal insulation. The part of the door and the poor roof insulation are shown in Figs. 9c and 9d. The same situation is in the depot with the collection of non-European weapons.

Figure 9 – Depot of old metal artifacts, a,b – side wall, c,d – roof, e,f – wall of the depot with the collection of non-European weapons
 Slika 9 – Depo zbirke starih metalnih eksponata, a,b-bočni zid, c,d – krov, e,f – zid depoa sa zbirkom neevropskog naoružanja

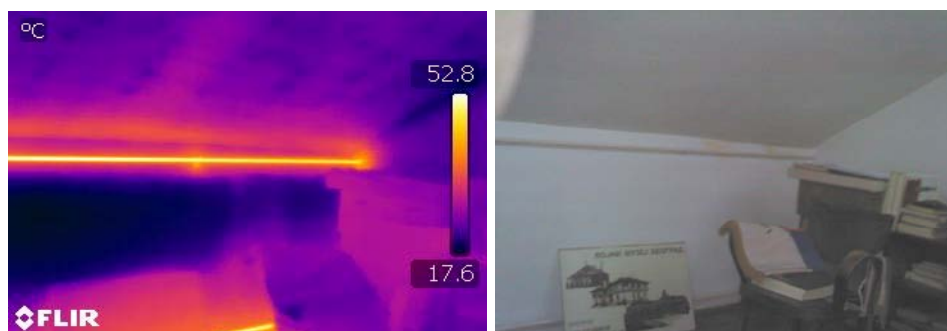
The thermal insulation is also very poor in the museum offices. Fig. 10 shows the thermogram and the photo recorded in the museum office located in the attic.

Figure 10 – Office in the attic, poor thermal insulation
 Slika 10 – Kancelarija u potkrovlju, loša termalna izolacija

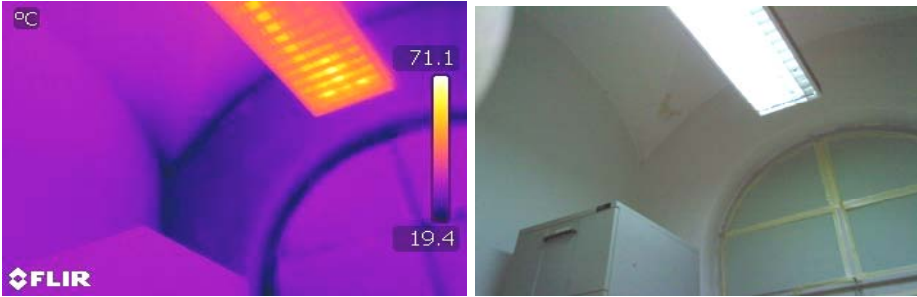
The thermographic tests of the photo collections depot confirm that there is no potential leak, penetration or condensation of moisture, only poor thermal insulation (Fig.11).

Figure 11 – Poor thermal insulation in the photo collections depot.
Slika 11 – Loša termička izolacija u depou sa zbirkom fotografija

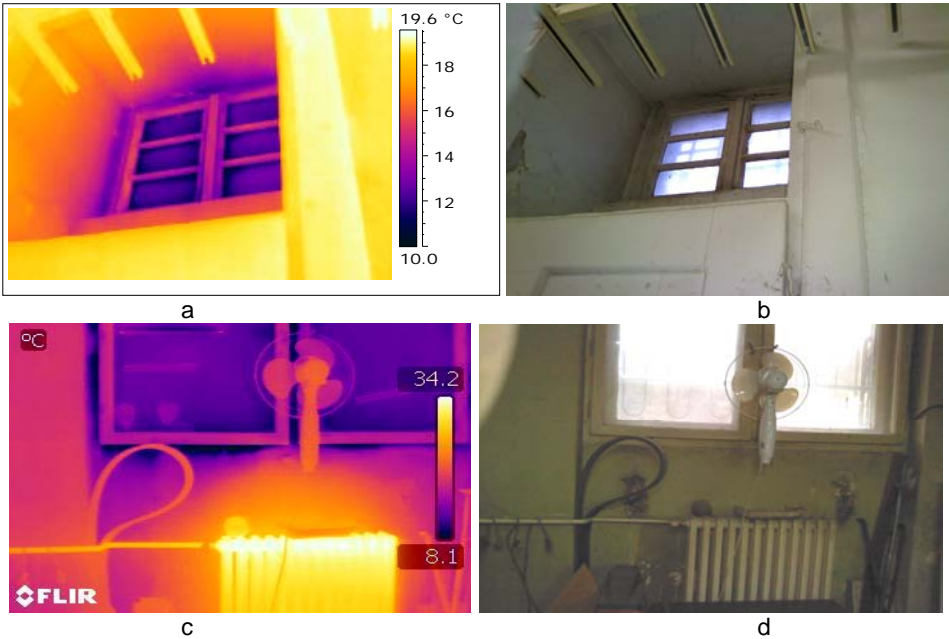
Visual and infrared images of some windows and doors of the museum building show the poorly sealing windows, with an air leakage. This is a very important malfunction for the energy efficiency of the building (Fig 12).

Figure 12 – Poorly sealing windows, cold air leakage, a,b – banners depot and c,d – in the workshop for metal conservation
Slika 12 – Lošo zaptivanje prozora, prodor hladnog vazduha, a,b – depo sa zbirkom ratnih zastava, c,d – radionica za konzervaciju metalnih eksponata
