Analysis of floating-head heat exchanger bolts failure

Abstract.

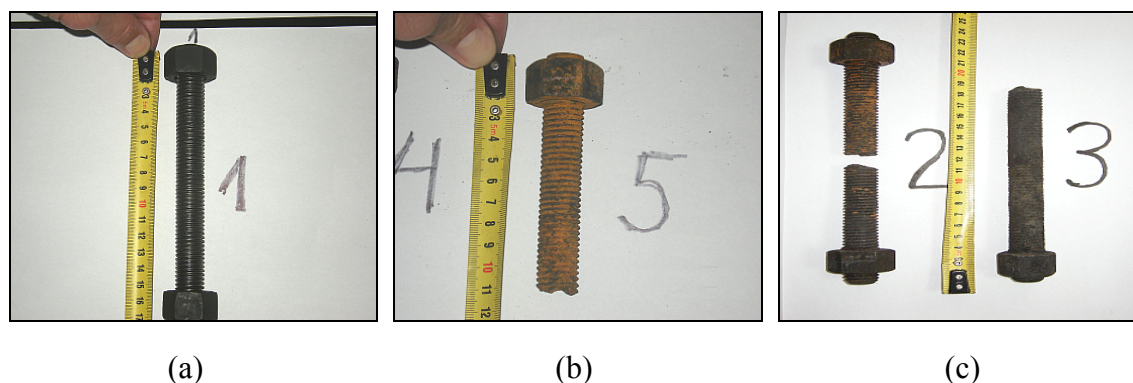
Preliminary visual examination of RBs hasn't shown any irregularities presence (Figure 1a). BBs were deposite-coated (Figure 1b and Figure 1c). Color of deposite was predominantly black (probably result of organic species presence). the light-gray and

brown-red deposit color was observed mixing with black deposit (probably the result of corrosion processes). Generally, all bolts had a complex topography of fractured surfaces (Figure 3). Common for all bolts was that fracture was initiated in the root thread. After initiation, cracks propagated through the stud in radial direction, sometimes abruptly changing the planes of propagation to the final fracture (Figure 2).

Figure 1. As-received (a) reference bolt (RB) and (b) and (c) broken bolts (BBs).

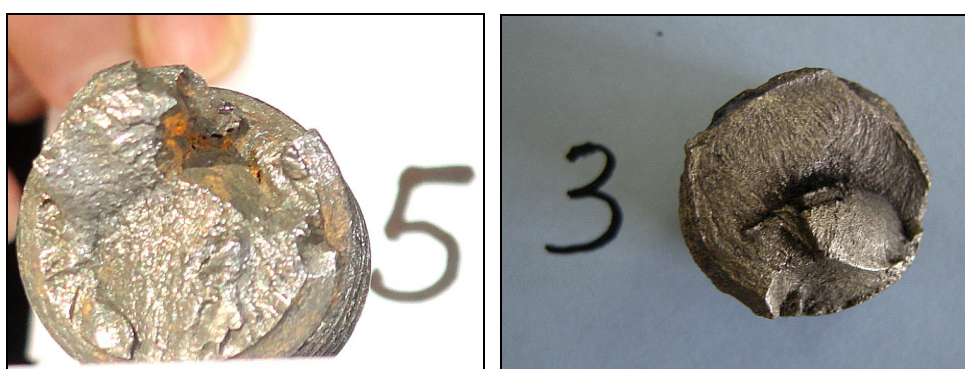
Radiography measurements have shown that several broken bolts had volume cracks 4 mm to 15 mm long, which expand in radial direction, and few in axial direction.

Figure 2. The appearance of fractured surfaces of BB No.5 (Figure 1b) and BB No.3 (Figure 1c).
The fractured surfaces are approximately 20 nm gold coated.

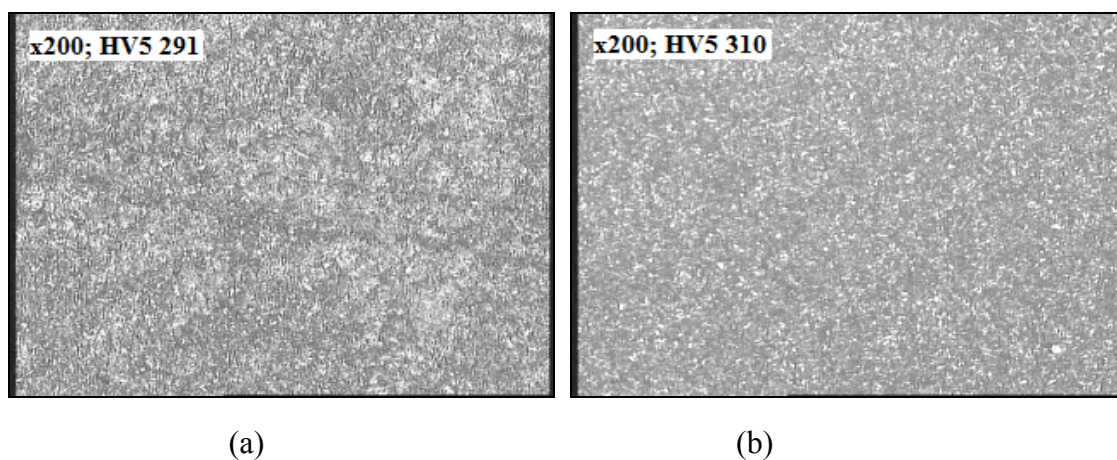
Secondary structure of both, RB and BB, consists probably of tempered martensite/bainite structures (dark etched areas), with small ferrite presence (white non-etched areas). There is a possibility that certain amount of pearlite is present, also. Bainite presence is possible if during quenching the cooling rate was lower than critical cooling rate for start of martensite transformation. Pearlite could have been formed from retained austenite during tempering procedure.

Appearance of secondary structure is similar when Figure 4a and Figure 4b are visually compared. Mechanical properties strongly depend on secondary structure. The values of mechanical properties of RB and BB differ significantly (see section 3.3), which suggest that there can be a possibility for some important differences in RB and BB secondary structure properties. More detailed analysis needs to be performed.

Figure 4. Cross-sectional photomicrographs of secondary structure of RB (a), and BB (b).

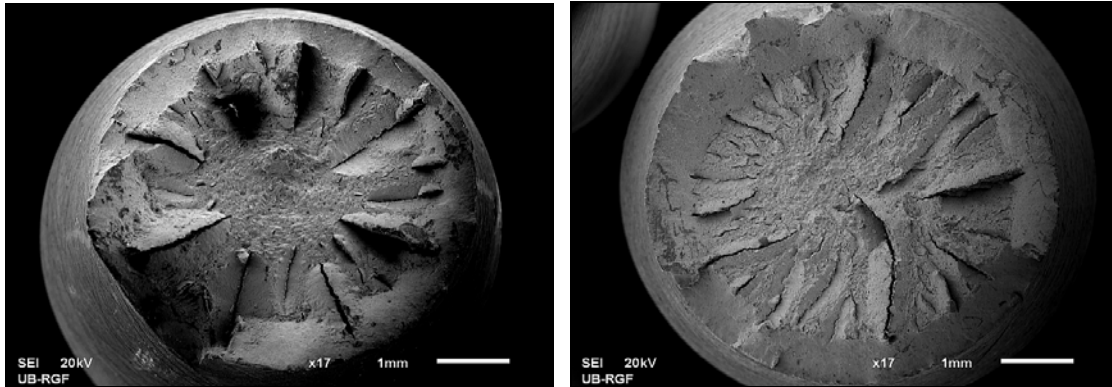
Figure 5 gives representative appearance of fractured surfaces of RB and BB tensile specimens. Both fractured surfaces have similar rosette-like appearance. The crack initiation site is at the centre of fibrous area and direction of propagation follows the radial ridges towards periphery. Both fractures have ductile appearance. In Figure 5a it can be observed that central fibrous zone is larger in comparison to that in Figure 5b. The radial ridges are more pronounced, also. These observations suggest that BB tensile specimens are less ductile than those of RB [6]. In addition, although here not presented, the

microfractography results have shown larger presence of cleavage facets on the BB than on RB fractured surface. Fracture mode can be characterized as dimple rupture and micromechanism as microvoid coalescence in the case of RB. The mixed presence of dimples and cleavage facets was noticed in the case of BB tensile specimens.

Figure 5. Macrofractographs of fractured surfaces of RB (a) and BB (b) tensile specimens. Secondary electron images.

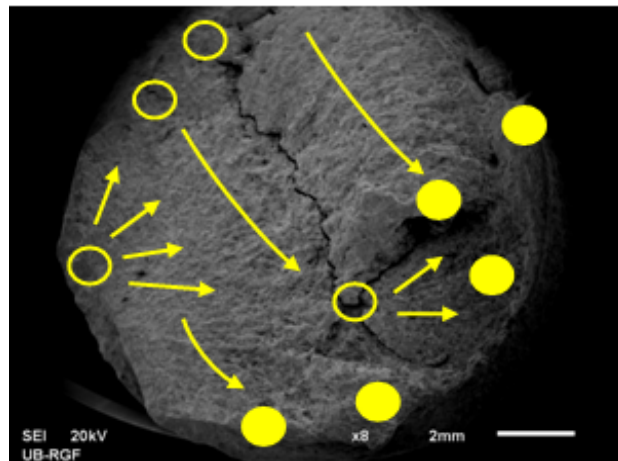
In almost all cases, fracture initiation occurred at the root of the screw thread, which is shown by open circles (○) in Figure 6. Also, it can be seen the change in direction of propagation indicated with the open circle at bottom right part of the figure. Straight arrows indicate the direction of crack propagation. Arc curves show the parts of the step-shape surface indicating the possibility that the propagation of fracture took place gradually in several stages. Full circles (●) represent areas of the final fracture. The general appearance of fracture is intergranular brittle-like. The micromechanism of fracture is difficult to determine because the fractured surface is covered with corrosion products (see section 3.6, Figure 8a).

Figure 6. Macrofractograph of fractured surface of BB during exploitation. Secondary electron image.

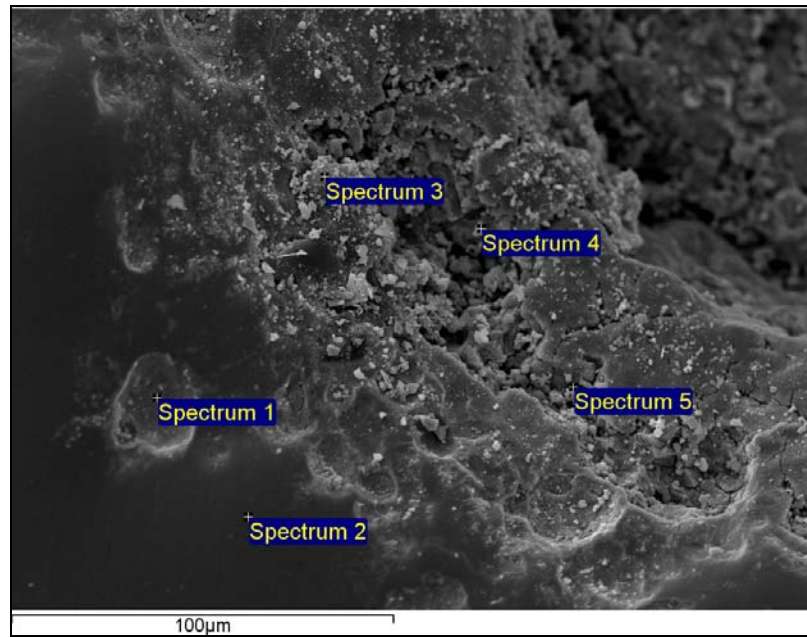
In Figure 7 it is shown the qualitative deposite chemistry analysis. The upper right part of Figure 7 is bolt thread side, while lower left side is part of the polished surface on the circumferential side of bolt radial cross-section. Here, the typical morphology of deposite can be observed. Spectrum 1 and 2 (Table 3) show presence of elements typical for bolt material (see also Table 2). Higher amount of carbon is considered as EDS measurement error. Chlorine- and sulphur-containing particles were identified and they are clearly presented in Table 3. Other EDS spectrums show presence of sulphur-containing species.

Figure 7. SEM-EDS single-point analysis of bolt deposite chemistry. Secondary electron image.

The results obtained after SEM-EDS analysis of both, bolt deposite and fractured surfaces chemistry revealed that there is an indication of presence of corrosive environment. Beside sulphur-containing species, which indicate on possible presence of H_2S , the chlorine-containing species are identified, also, indicating on possible presence of HCl . Although only a presence of H_2S is sufficient for failure to happen [1,2], the additional presence of HCl could enhance this effect [5].

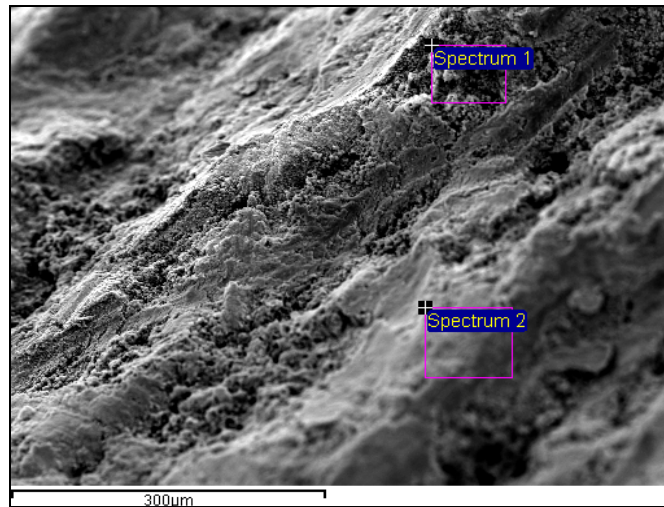
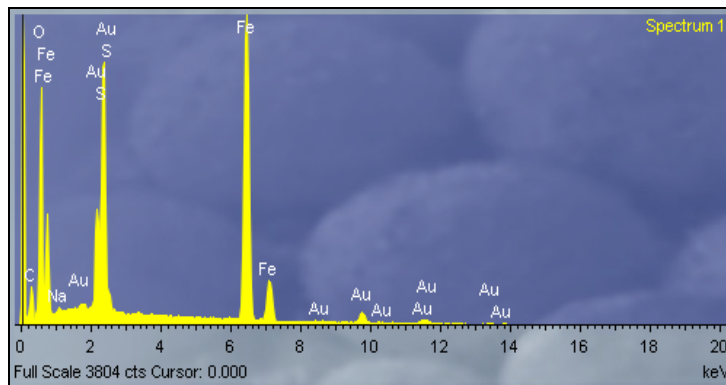
Figure 8a shows locations of areas where EDS analysis was performed. In Figure 8b the characteristic X-ray $K\alpha$ peak for sulphur can be observed. This peak is located near $K\alpha$ for gold. However, by careful analysis it was concluded that belongs to sulphur.

Figure 8. SEM-EDS area-analysis of fractured surface chemistry. Detail of fractured surface (a) and EDS spectrum (b) corresponding to Figure 8a. Secondary electron image.
